## TARGETED MOISTURE AND MOLD ASSESSMENT REPORT

### New College Residential Buildings PEI 2 and PEI 3

5800 Bay Shore Road  
Sarasota, Florida 34243

23-401745.2

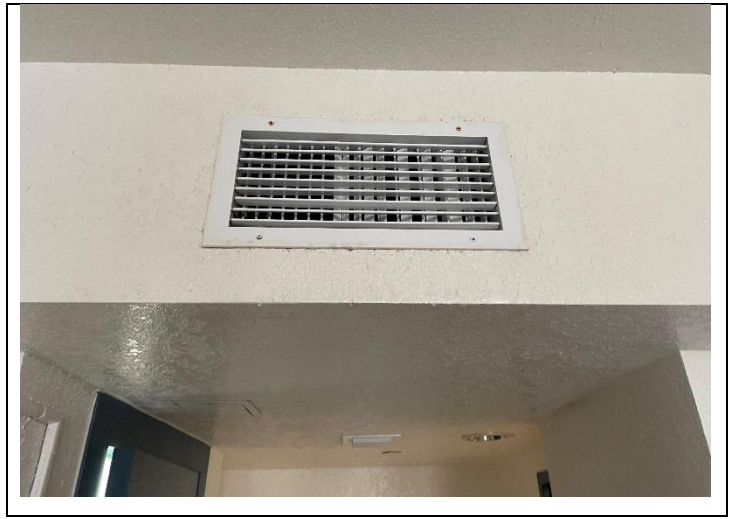
8. View of condensate on supply diffuser in PEI 216

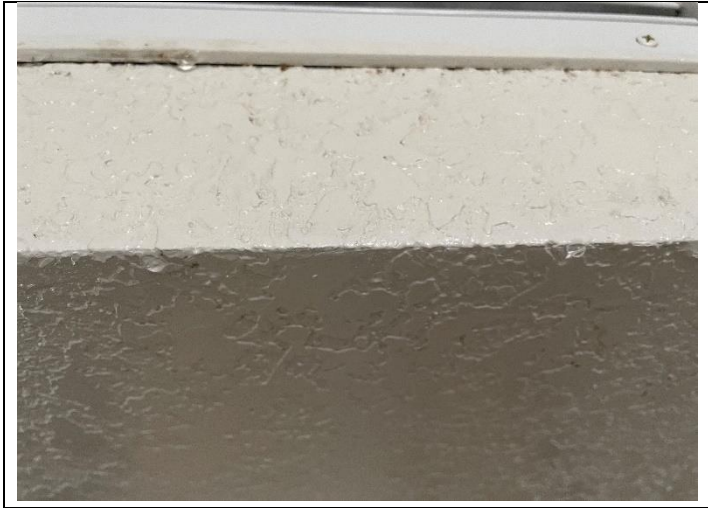
9. Close up view of condensate on supply diffuser in PEI 216

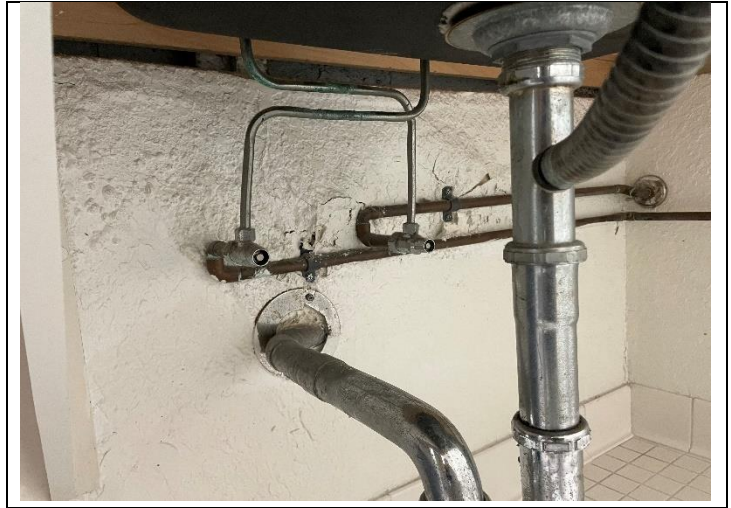
10. View of long term water damage and efflorescence on wall under restroom sink in PEI 205

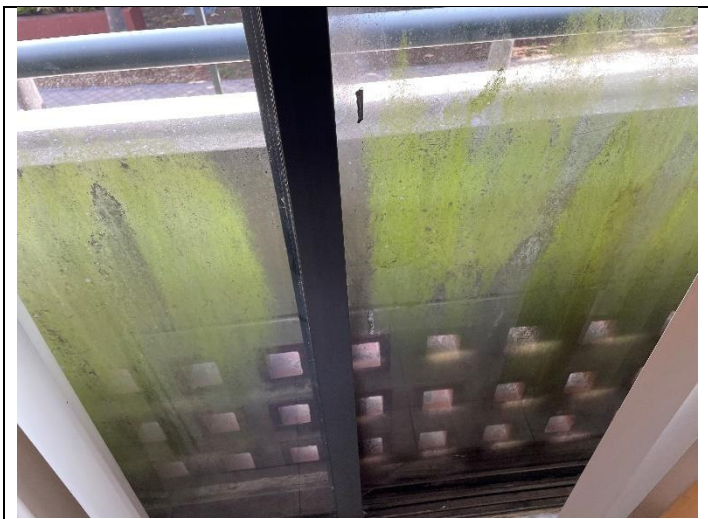
11. View of typical water exposure and algae buildup on exterior sliding door in PEI 212

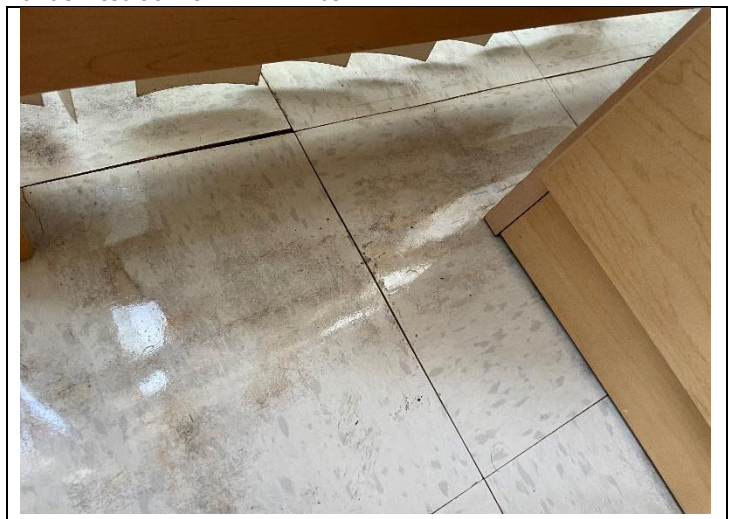
- Water-damaged floor tiles, delaminating from the substrate, were commonly observed adjacent to sliding glass door areas.
- Cracked/unseated seals around windows and sliding glass doors were observed allowing hot humid air to enter the living areas.

12. View of water-damaged floor tiles adjacent to sliding balcony door in PEI 212

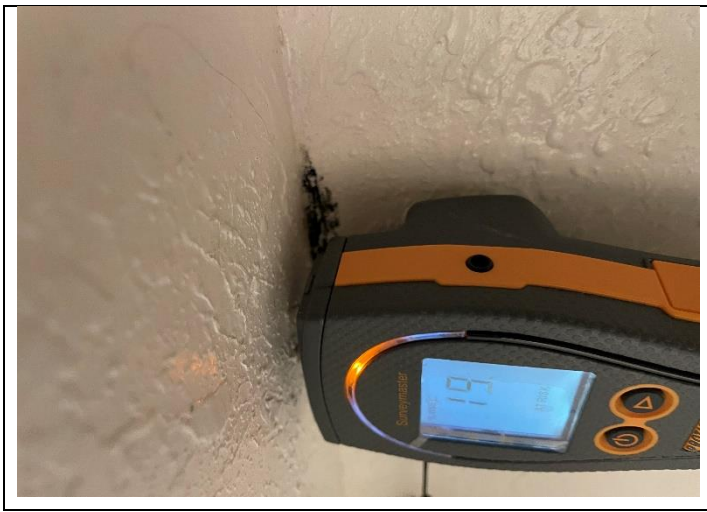
13. View of SVG and elevated moisture levels using Protimeter under restroom sink in PEI 221

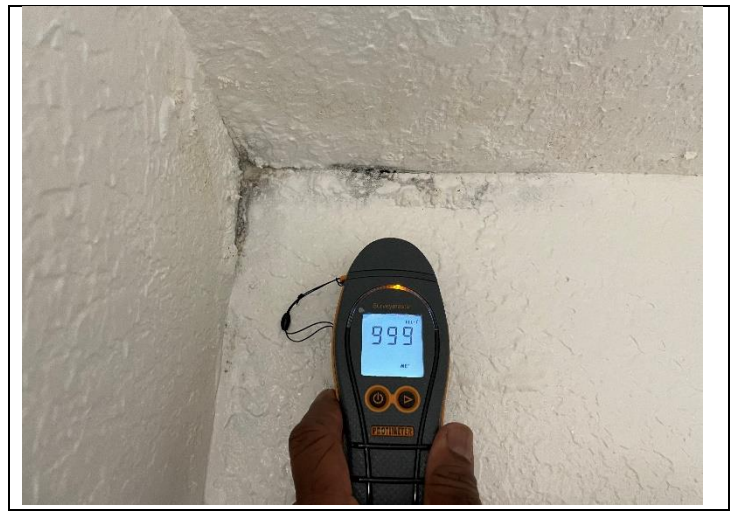
14. View of SVG and elevated moisture levels using Protimeter on restroom ceiling PEI 223

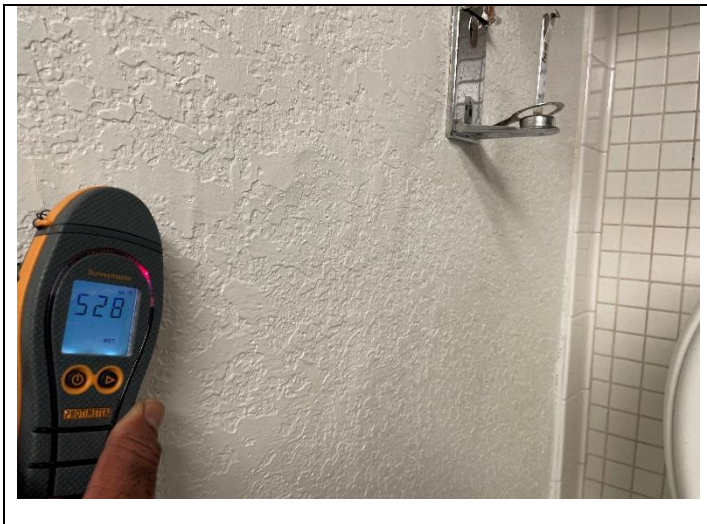
15. View of elevated moisture levels using Protimeter in restroom of PEI 227

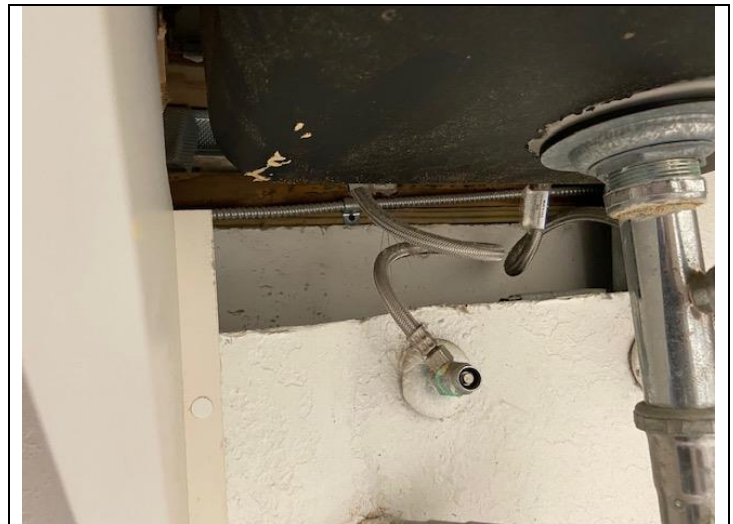
16. View of SVG under sink in PEI 232

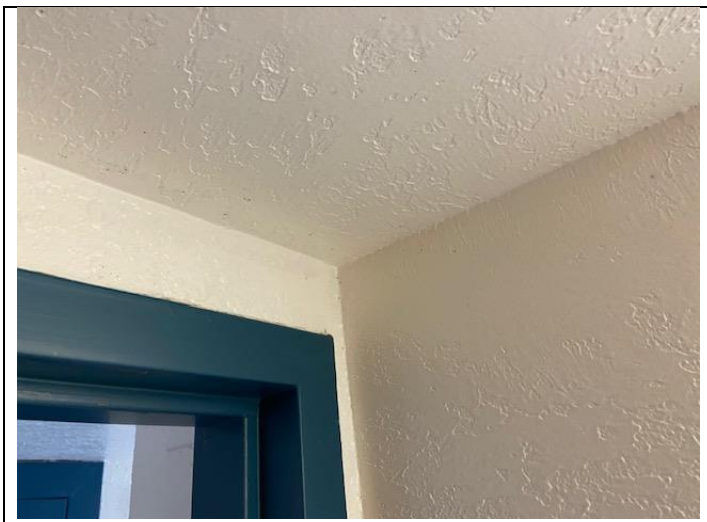
17. View of SVG on unit ceiling (outside restroom) of PEI 232

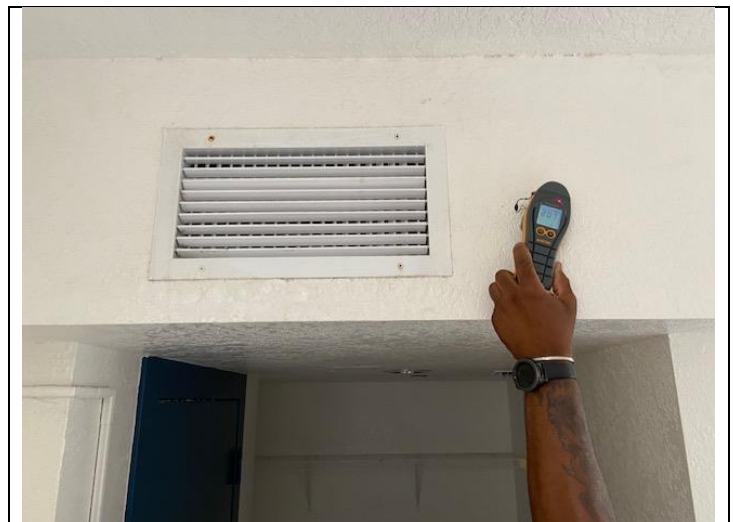
18. View of elevated moisture levels using Protimeter around supply diffuser in PEI 230

- Use of a rubber seal between metal supply vents/diffusers and building material may control water/SVG damage on the walls, ceilings or ceiling panels.

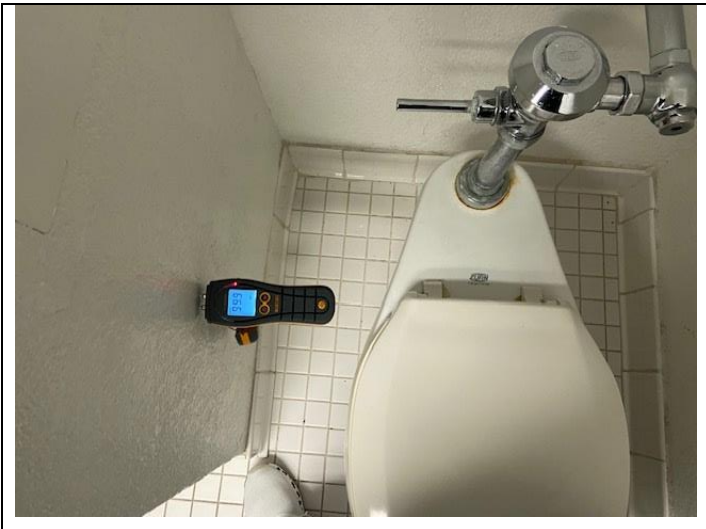
19. View of elevated moisture levels using Protimeter on wall material surrounding toilet in PEI 238 (similarly found in PEI 227, 225, 236, 241, 242)

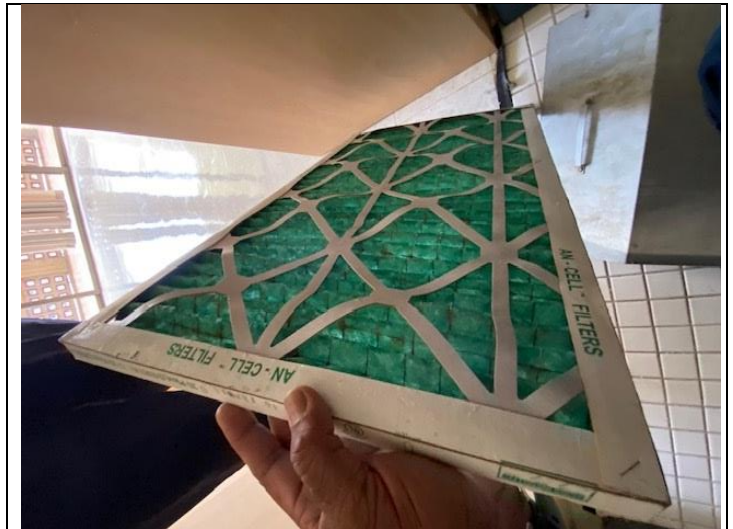
20. View of saturated HVAC filter found in PEI 240

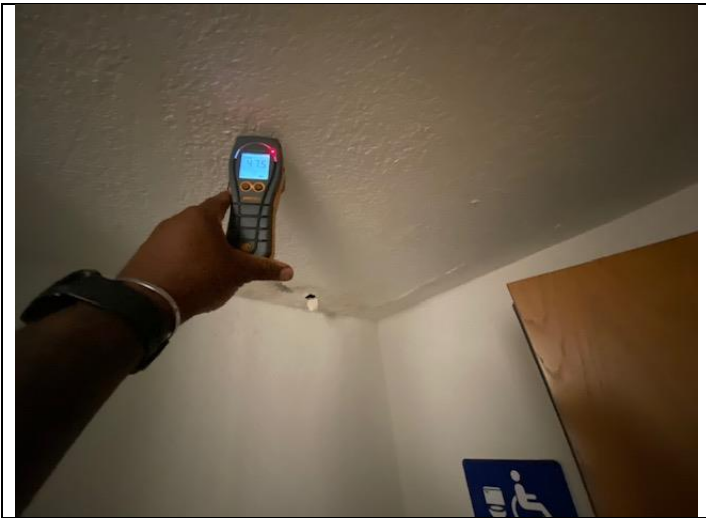
21. View of SVG with elevated moisture levels using a Protimeter on ceiling outside restroom in PEI 2 Lounge

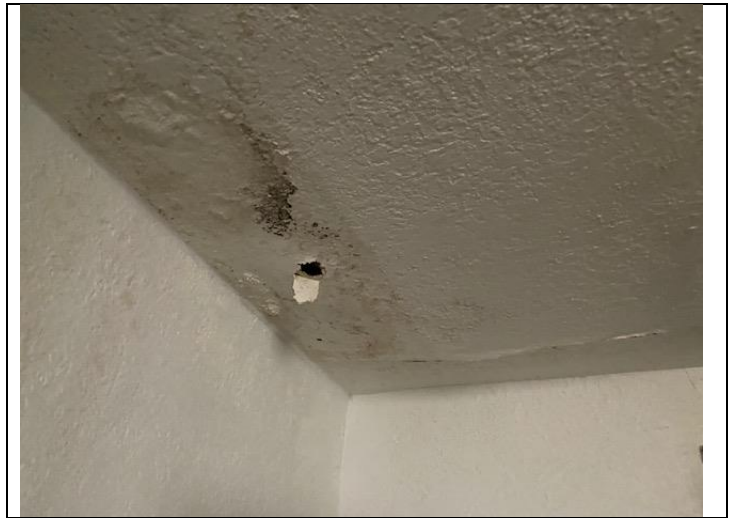
22. Close up view of SVG on ceiling outside restroom in PEI 2 Lounge

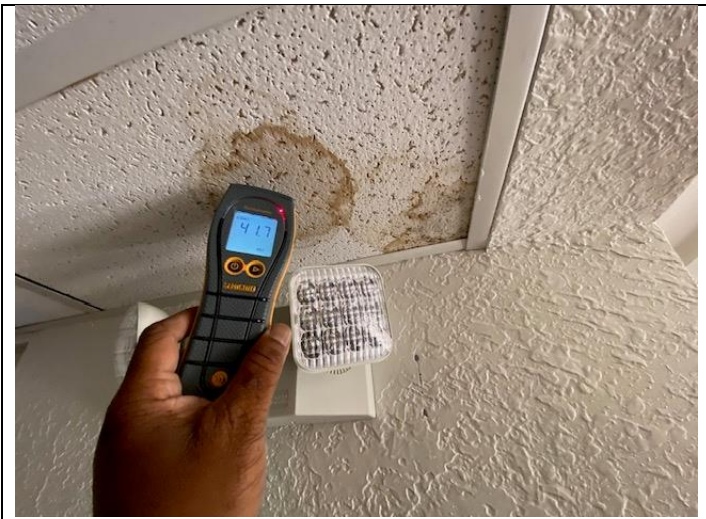
23. View of water damaged ceiling tile with elevated moisture levels using Protimeter in PEI 2 Lounge kitchen

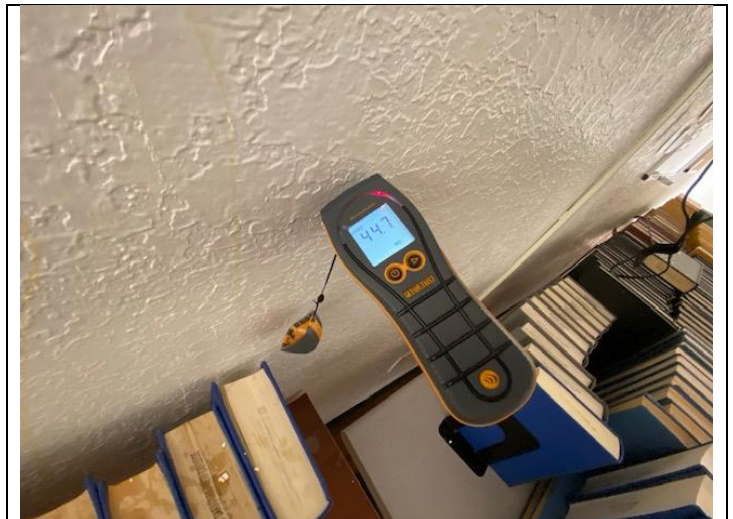
24. View of elevated moisture using Protimeter on south wall in PEI 2 Lounge

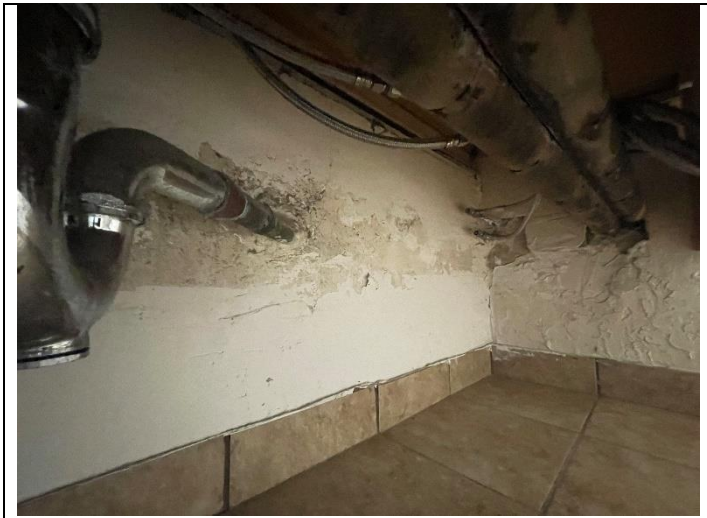
29. View of moisture damage under restroom sink in PEI 305

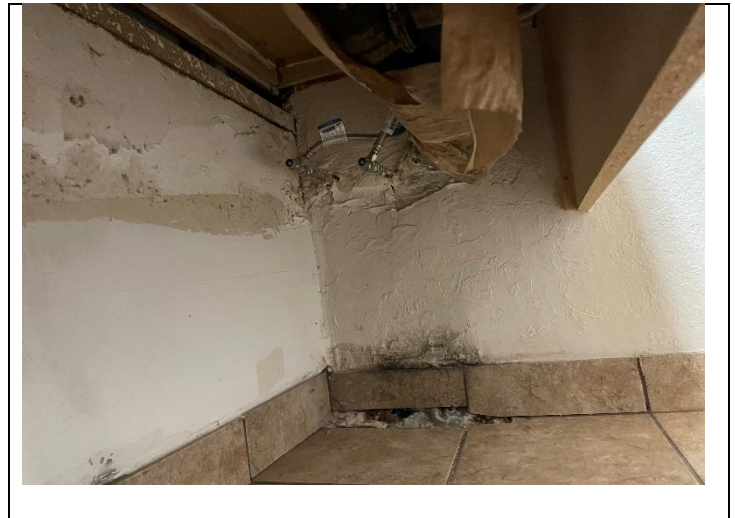
30. View of SVG and moisture damage under restroom sink in PEI 307

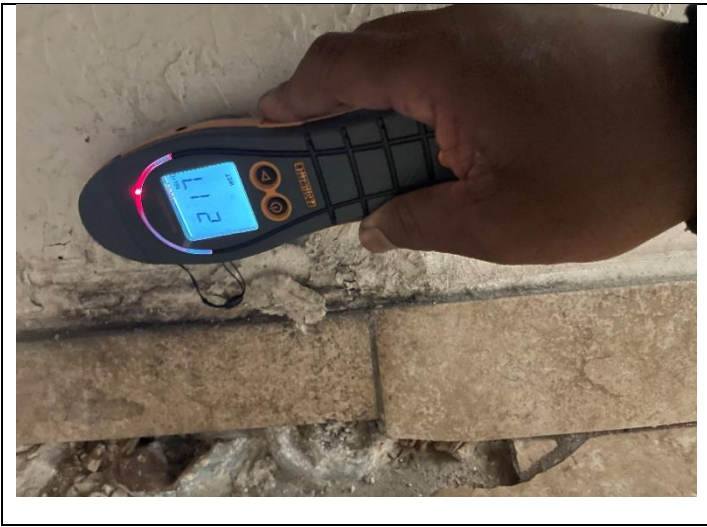
31. View of SVG and elevated moisture using Protimeter under restroom sink in PEI 307

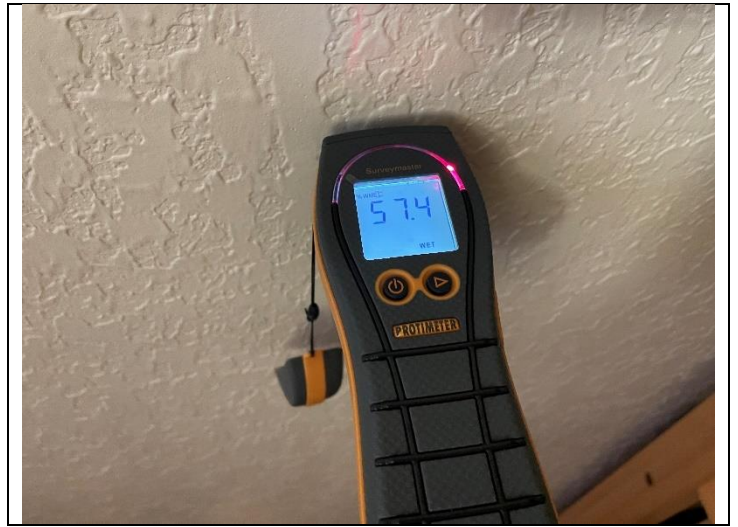
32. View of elevated moisture in ceiling and wall material around HVAC system in PEI 307

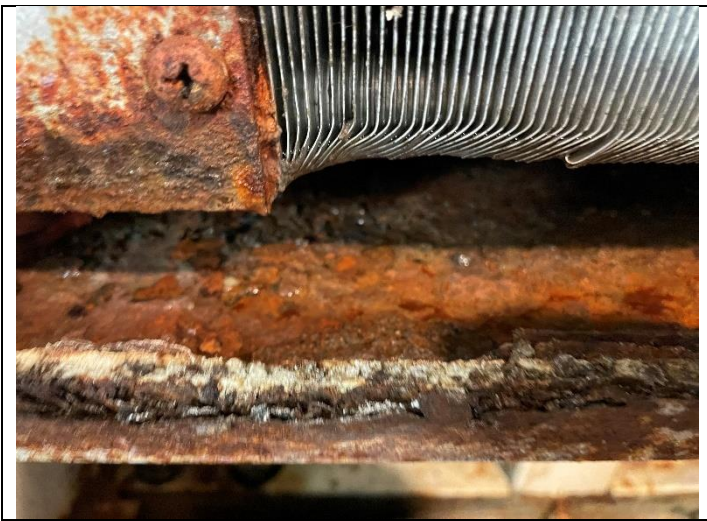
33. View of rusted HVAC drip pan in PEI 307

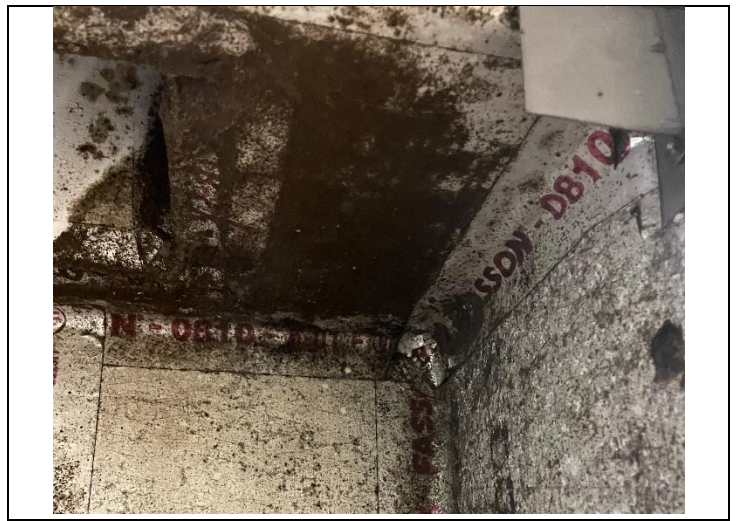
Aged, dusty, and rusted HVAC units were observed in all of the assessed units. Some were observed to have mis-aligned condensation drain pans causing moisture damage to surrounding building materials. The system observed in unit 315 was observed to have surficial SVG present on the unit housing and various components on the interior of the unit. Return chambers in some systems were observed to have standing debris visible. An HVAC filter in the system of unit 204 was observed to be saturated with condensation. The HVAC units were functioning, but possibly not operating effectively or efficiently due to their observed conditions.

34. View of SVG on top right corner of HVAC system in PEI 315

- ❖ The identified surficial SVG inside the interior of the HVAC unit within unit 315 should be cleaned by a Florida licensed mold remediation contractor. It is also recommended to utilize the same approach for any other AHUs encountered where similar conditions are identified.

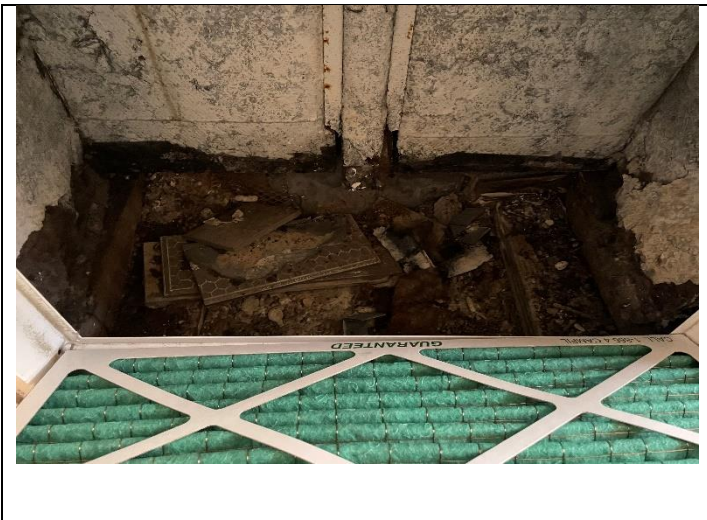
35. View of broken HVAC return box with visible debris in PEI 317

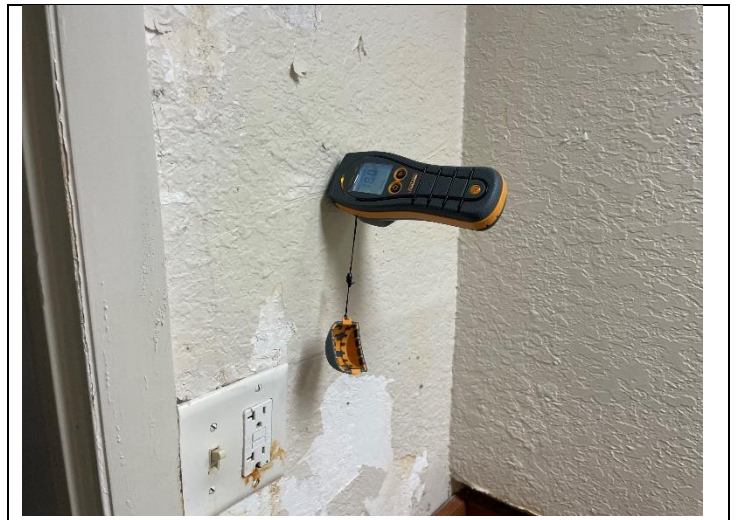
36. View of water damage and elevated moisture levels using Protimeter in restroom walls of PEI 345

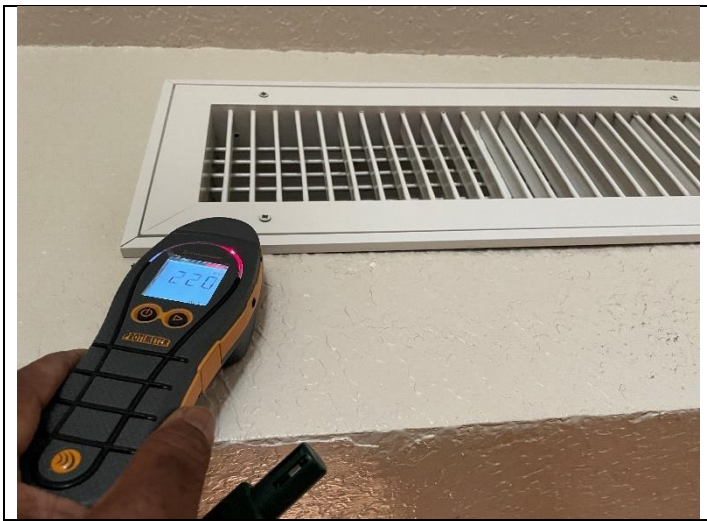
37. View of elevated moisture levels using Protimeter around supply diffuser in PEI 345

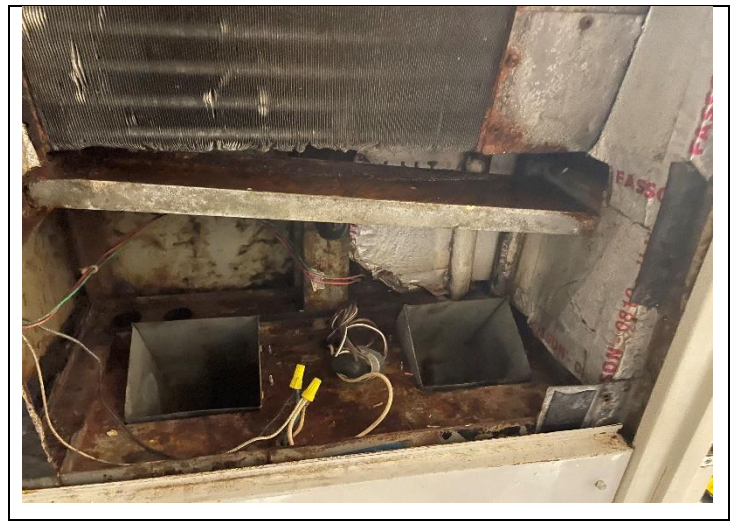
38. View of damaged condensate pan support, draining to wall in PEI 345

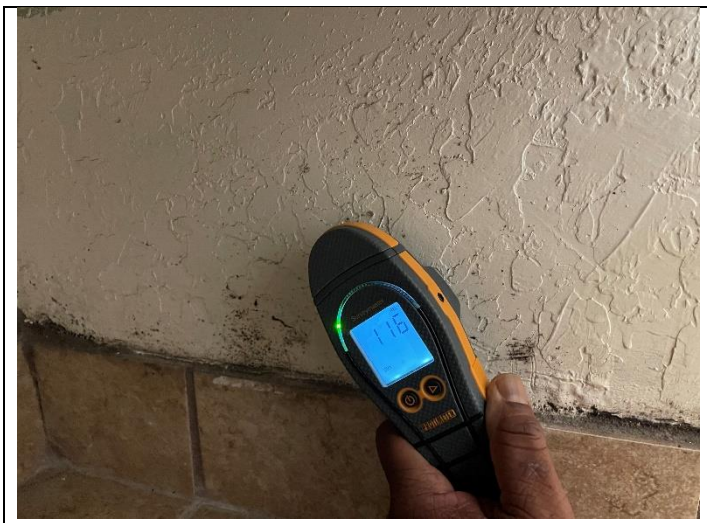
39. View of SVG with dry moisture level with Protimeter under restroom sink in PEI 331

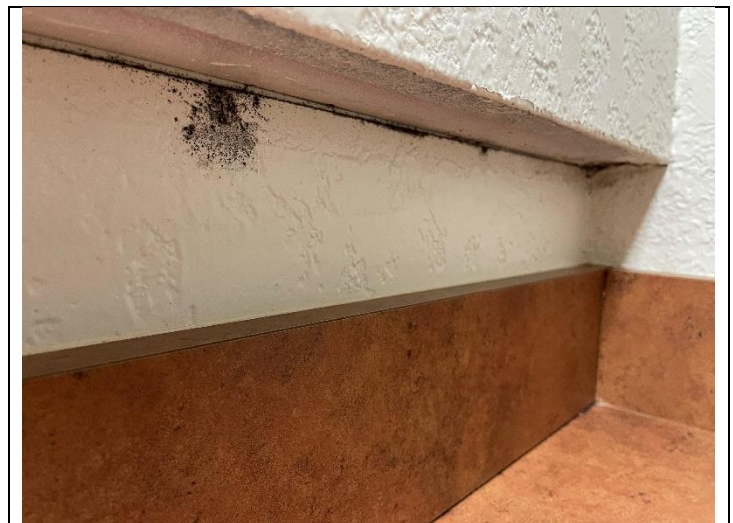
40. View of SVG under restroom mirror PEI 331

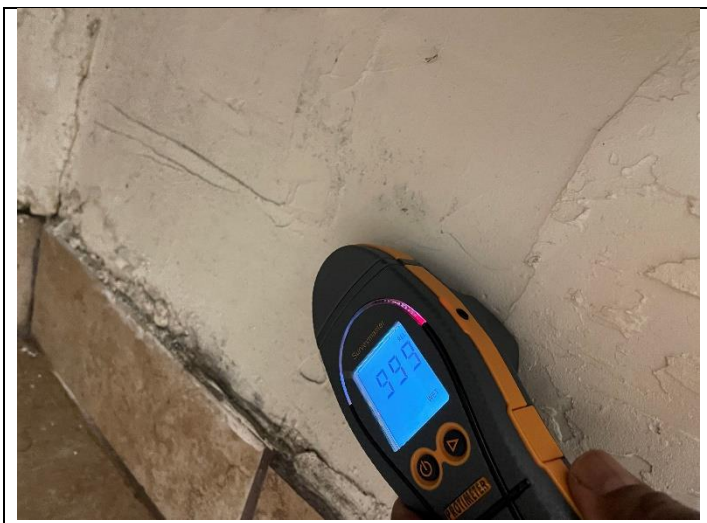
41. View of SVG and elevated moisture level with Protimeter under restroom sink in PEI 308

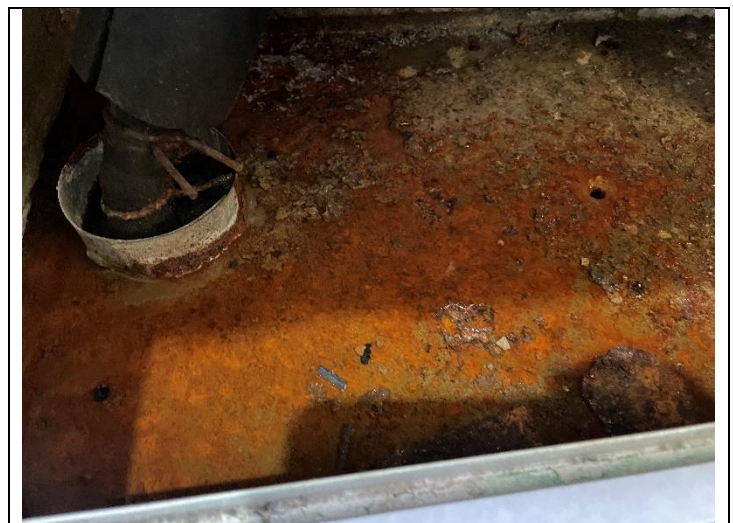
42. View of standing water in HVAC return box likely caused by drip pan out of alignment

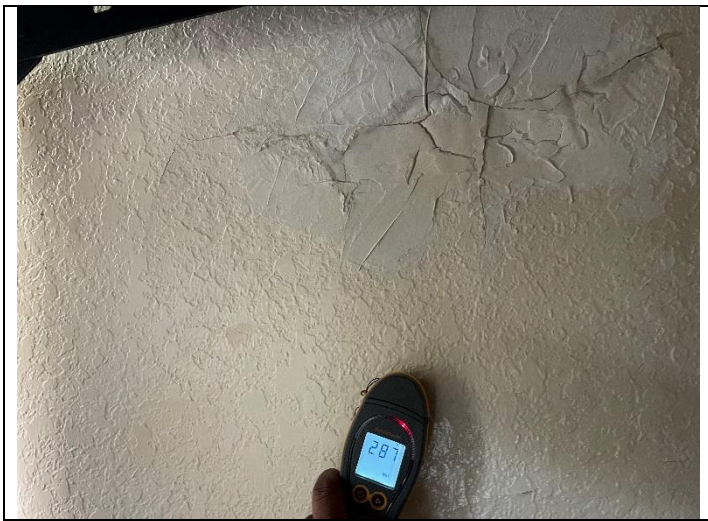
43. View of moisture damage and elevated moisture with Protimeter on North wall in PEI 342

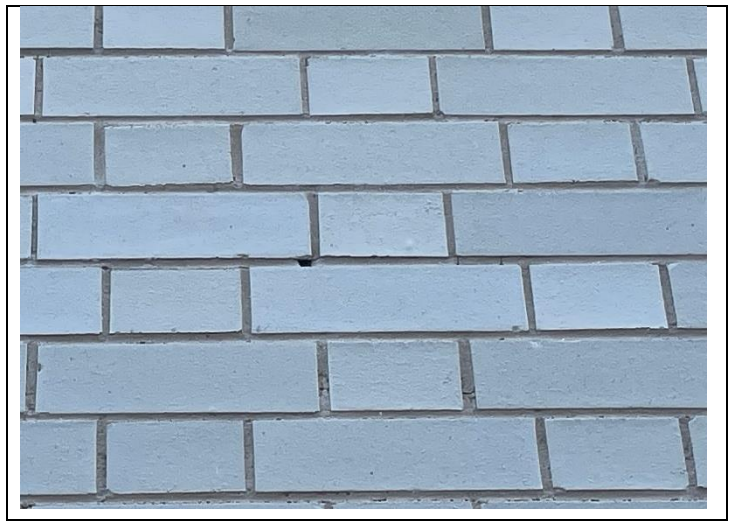
44. View of typical exterior PEI 2 and 3 buildings with identified holes in grout.

- ❖ Due to observed cracking in exterior brick façade, spalling concrete on building walls, balconies and stairs, and damaged floor tile & grout on balconies, conduct an envelope evaluation to resolve moisture intrusion areas of the PEI 2 and PEI 3 buildings. Recurrent moisture intrusion will lead to recurrent SVG.

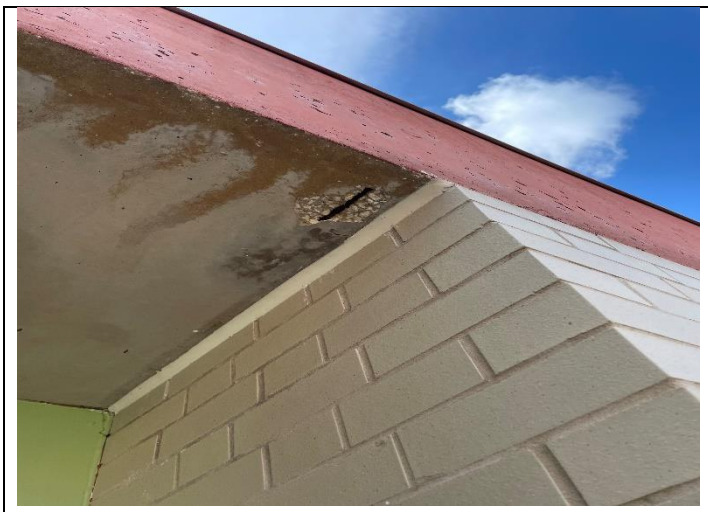
45. View of typical exterior PEI 2 and 3 buildings with visible water damage and spalling of concrete

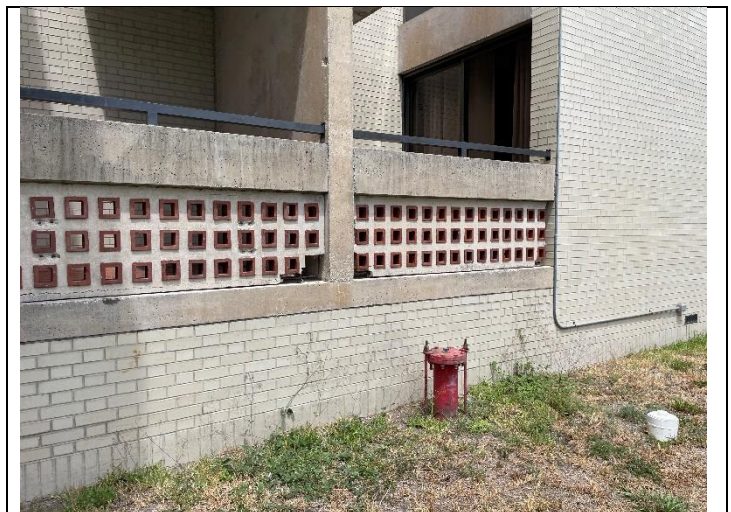
46. View of typical balcony for PEI 2 and 3 buildings with visible brick damage

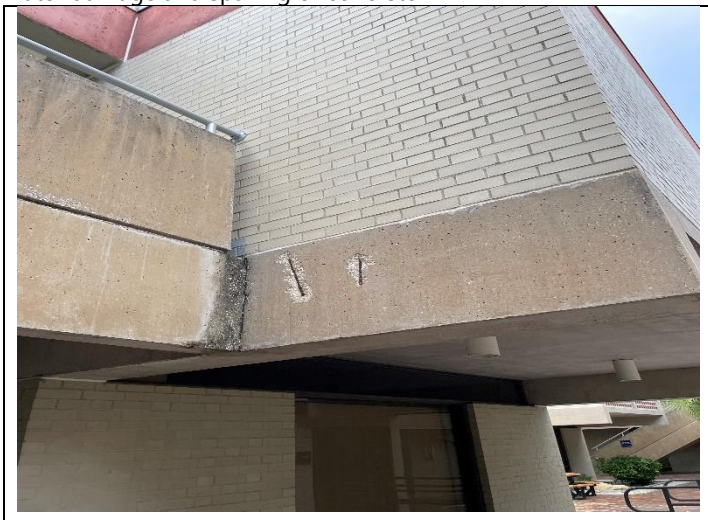
47. View of typical exterior PEI 2 and 3 buildings with visible water damage and spalling of concrete.
