TARGETED MOLD & MOISTURE ASSESSMENT REPORT

Residential / Dormitory Buildings

5800 Bay Shore Road
Sarasota, Florida 34243

May 22, 2023
Partner Project No. 23-401745.1

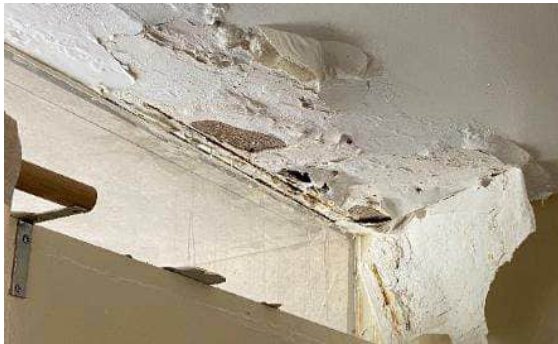
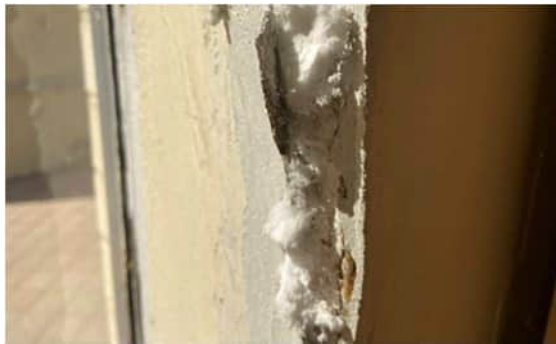
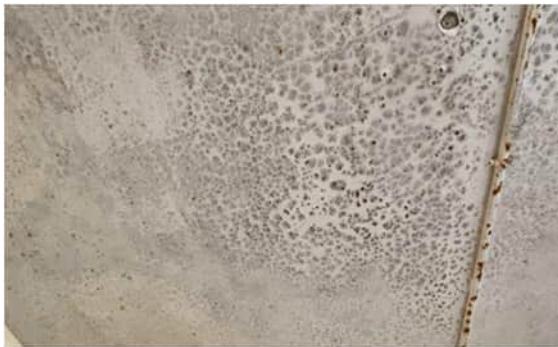
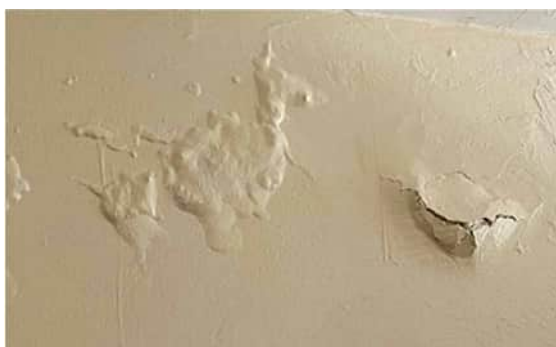
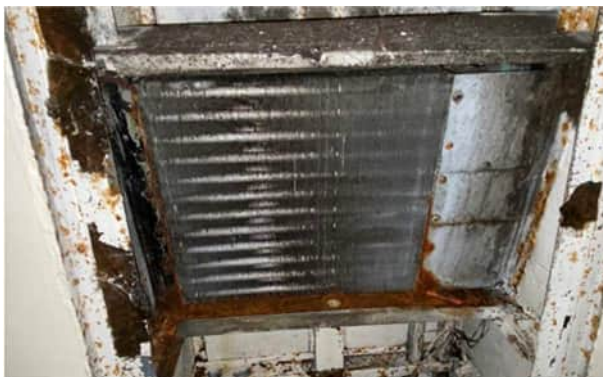
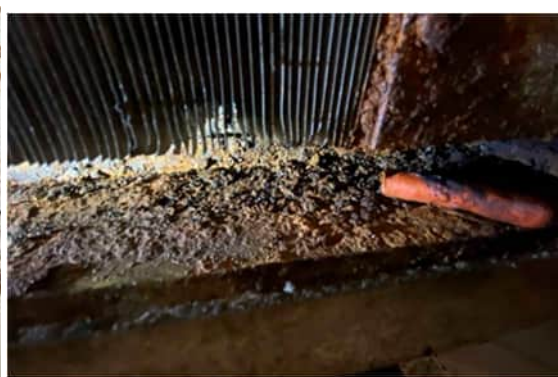
Building PEI 1

PEI Buildings 1, 2 & 3 - The historical moisture damage and suspect visible mold identified in these buildings is evidence of a systematic problem. Based on our observations and experience the interior damage is the result of roof leaks, exterior envelope failure allowing moisture to intrude and further exacerbated by HVAC conditions and HVAC units that are not functioning effectively or efficiently. Limited to no dehumidification or maintaining temperature controls provides an environment conducive to mold activity. Additionally, evidence of efflorescence and spalling in the building materials indicates a long-term problem with only interior areas patched and/or temporarily repaired without addressing the underlying envelope issue. The occupied units assessed in PEI 3 revealed similar circumstances, however at less of a scale.

- Suspect Visible Mold on ceilings and walls
- Heavy dust load and Suspect Visible Mold on HVAC vents.
- Moisture damaged ceiling and wall building materials
- Efflorescence damaged ceiling and wall building materials
- Moisture intrusion through cracks in cast-in-place concrete ceiling decks
- Dusty/dirty/rusted HVAC units with Suspect Visible Mold
- Building materials were “dry” in units assessed

- ❖ These buildings should not be occupied in their current condition. A fiscal investment is required to conduct an envelope evaluation, complete the exterior and interior structural damage repair and renovation and the changeout of HVAC systems to replace current HVAC systems.

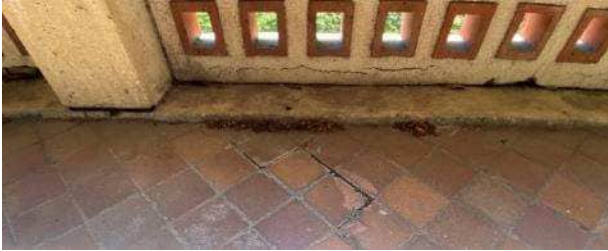
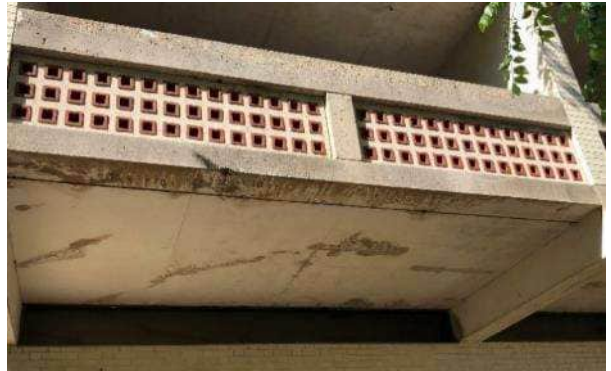
Building 1 PEI 1 Exterior

- Cracked exterior brick façade – Brick and Mortar
- Spalling concrete – Building walls, balconies, stairs
- Damaged tile & grout on balconies

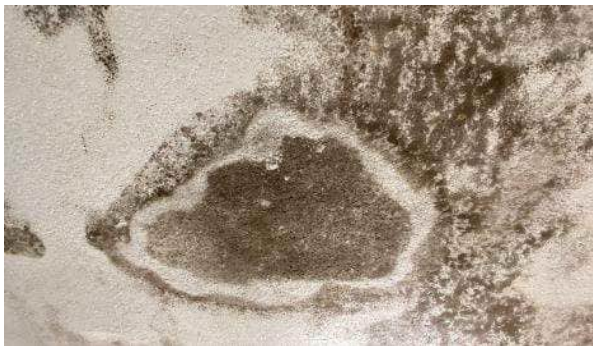
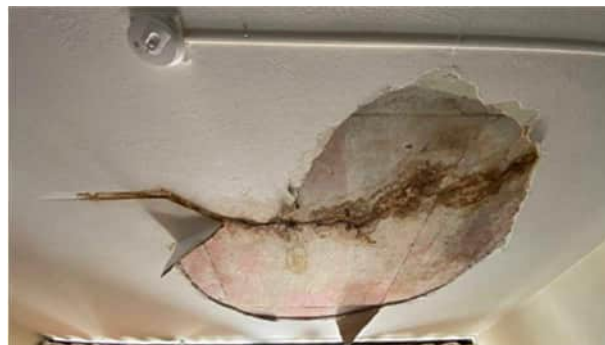
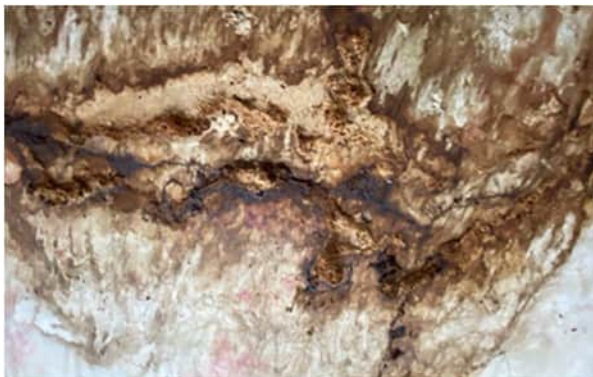
Building PEI 2

- Suspect Visible Mold on ceilings and walls
- Heavy dust load and Suspect Visible Mold on HVAC vents.
- Moisture damaged ceiling and wall building materials
- Efflorescence on damaged ceiling and wall building materials
- Potential moisture intrusion through cracking in cast-in-place concrete ceiling decks
 - Unit 247
- Dusty/dirty/rusted HVAC units with Suspect Visible Mold
- Water-damaged floor tiles, delaminating from substrate
- **“Wet”** building materials were identified in the following units included in our assessment
 - Unit 247 – Ceiling in shower
 - Unit 246 – Wall

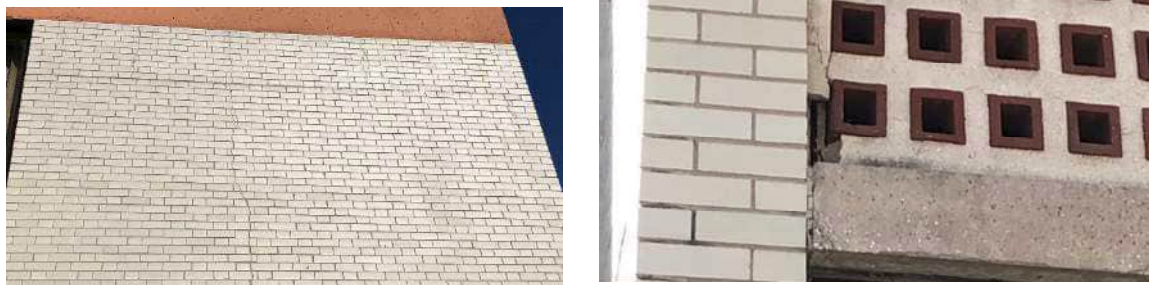
Building PEI 2 Exterior

- Cracked exterior brick façade – Bricks and Mortar
- Spalling concrete – Building walls, balconies, stairs
- Damaged floor tile & grout on balconies

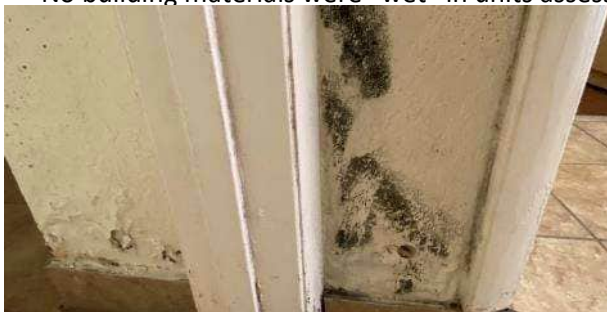
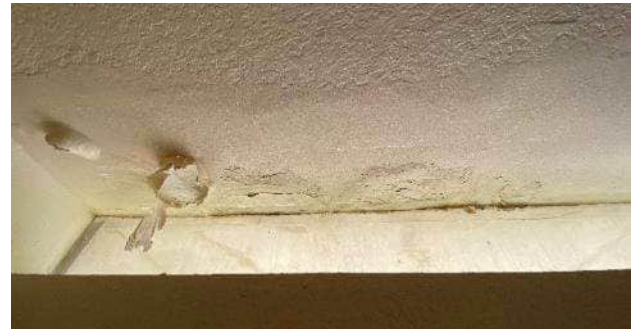
Unoccupied Units:

- Suspect Visible Mold on ceilings and walls
- Heavy dust load and Suspect Visible Mold on HVAC vents.
- Moisture damaged ceiling and wall building materials
- Efflorescence on damaged walls and ceiling building materials
- Dusty/dirty/rusted HVAC units with Suspect Visible Mold
- Water-damaged floor tile, delaminating from substrate
- No building materials were “wet” in units assessed

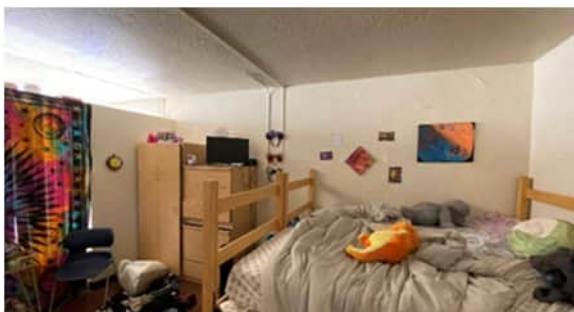
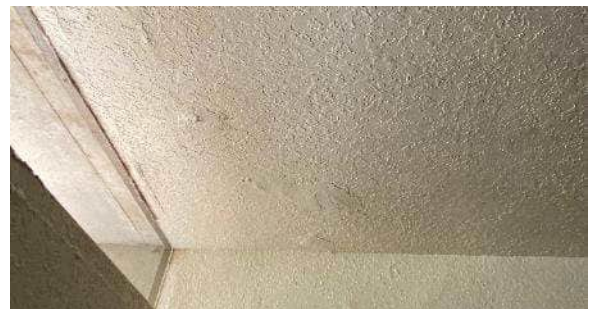
Occupied Units:

- Suspect Visible Mold on ceilings and walls
- Heavy dust load and Suspect Visible Mold on HVAC vents
- Moisture damaged ceiling and wall building materials
- Efflorescence on damaged ceiling and wall building materials (see above)
- Dusty/dirty/rusted HVAC units with Suspect Visible Mold
- No building materials were “wet” in units assessed
- Damaged tile & grout on balconies

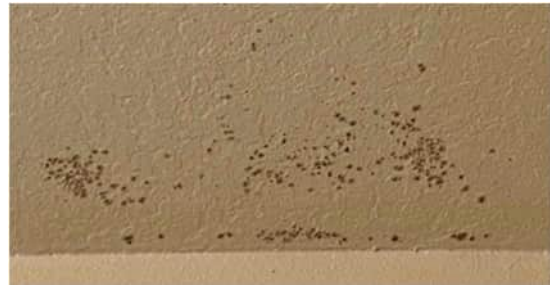
Occupied Units:

Building Z – Minimal moisture damage observed in the occupied areas such as suspect visible mold on ceilings in unit restrooms and moisture-stained ceiling tiles in the shared areas. The building’s exterior revealed cracking in the façade, and possible structural damage on a balcony overhang. Mineral leaching observed from overhead areas onto brick façade causing calcification deposits below occurs with constant available moisture. The rust spots observed permeating through the stucco exterior indicate moisture is penetrating through the stucco surface to corrode the metal below. The identified exterior deficiencies lead to significant interior building material and structural damage if not permanently addressed, as evident in this building with only temporary patching or repairs and painting.

- Suspect Visible Mold on ceilings in restrooms
- No building materials were “wet” in units assessed at the time of the assessment

- ❖ Remove and replace moisture-stained ceiling tiles. Inspect nearby HVAC metal vent and ducts for condensation/sweating or plumbing failures or roof leaks. Use of rubber seal between metal vents/diffusers and ceiling material may minimize water/mold damage.
- ❖ Check ventilation and/or exhaust in restrooms for adequate flow of conditioned air and exhaust of moist air.
- ❖ A fiscal investment is required to conduct an envelope evaluation and complete exterior structural damage repair and interior renovations.

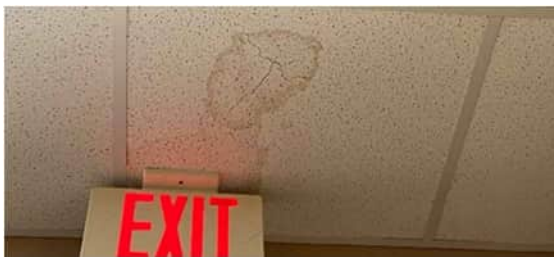
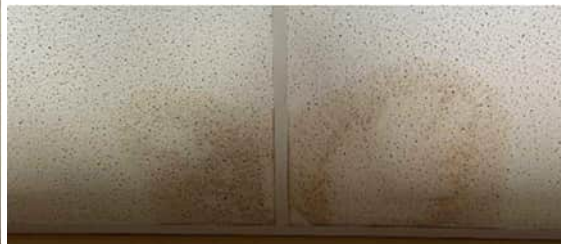
Common Areas:

- Water-stained ceiling tiles

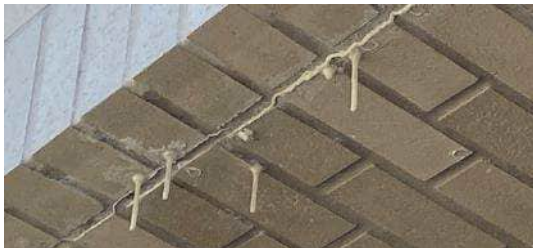
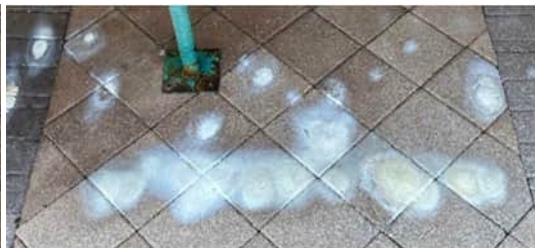
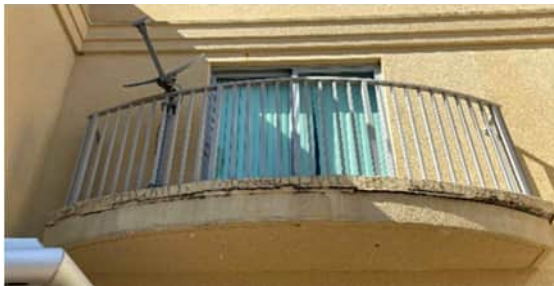
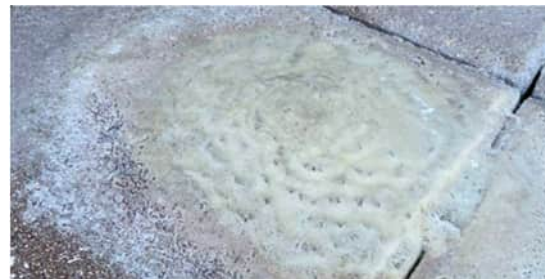
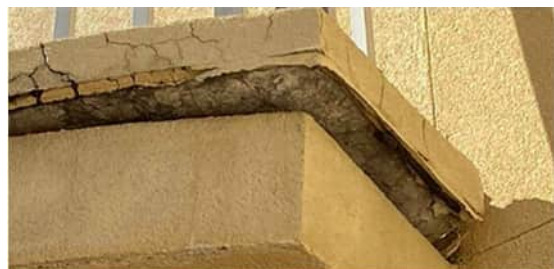
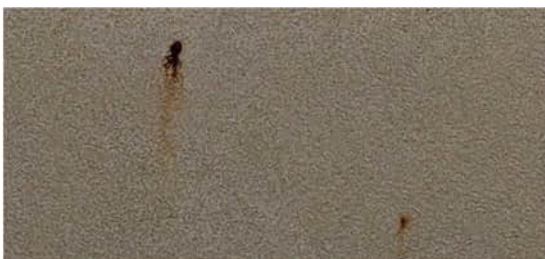
Exterior:

- Mineral leaching from concrete onto brick façade and dripping onto sidewalk
- Structural damaged balcony overhang at 2nd floor South
- Rust permeating through stucco exterior.

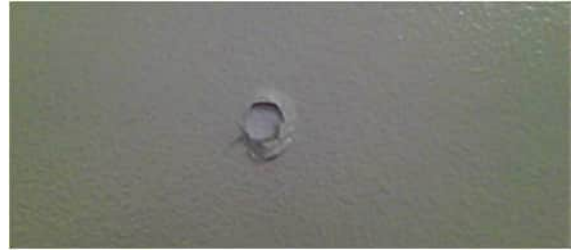
Occupied Units:

- Moisture damaged wall building materials
- No building materials were “wet” in units assessed

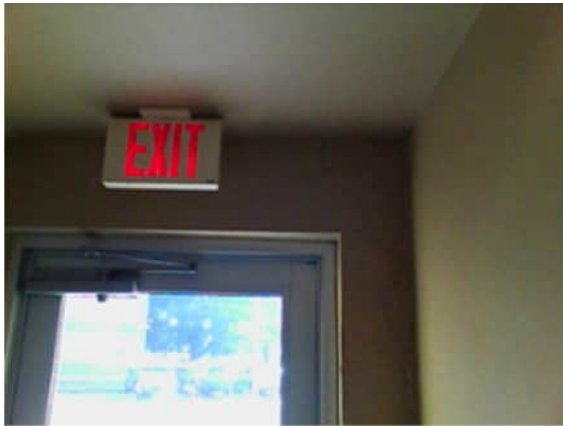
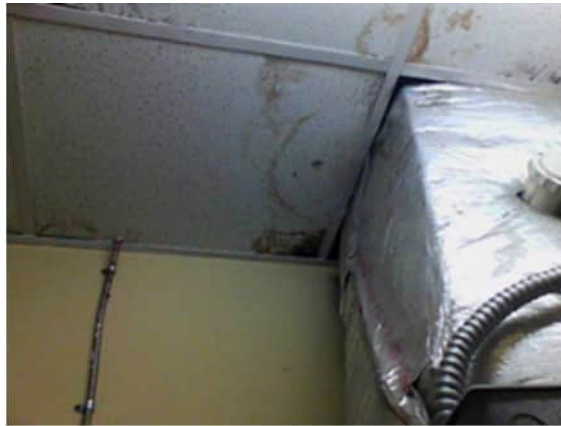
Building V Common Areas:

Buildings V, W, X & Y - Minimal to no moisture damage observed in the occupied areas. The moisture-stained ceilings and walls on the ground floor adjacent to the east exit doors is present in all four (4) buildings and may be a design defect, whereas the moisture-stained walls in shared areas adjacent to windows may be due to component (frame) seal failure. Moisture damage on drop-in ceiling panels within 1st floor shared area HVAC closets could be related to sweating HVAC ducts, plumbing failures or roof leaks.

- Moisture damaged building materials on perimeter wall near exit in 1st FL Common area
- Moisture damaged building materials on dropped ceiling of HVAC Closet in 1st FL Common area

- ❖ Evaluate the exit door area for a source or pathway for moisture intrusion and take appropriate corrective actions. Replace mold/water damaged building materials once corrective action is completed. Leaving water damaged building materials in place is not recommended due to the fact that mold, even though not visible, is present/dormant and will become active again quickly.
- ❖ Remove water damaged ceiling panels in HVAC closets and inspect duct work and plumbing above, as well as roofing for source of moisture intrusion and water damage. Replace water damaged materials once corrective actions completed.

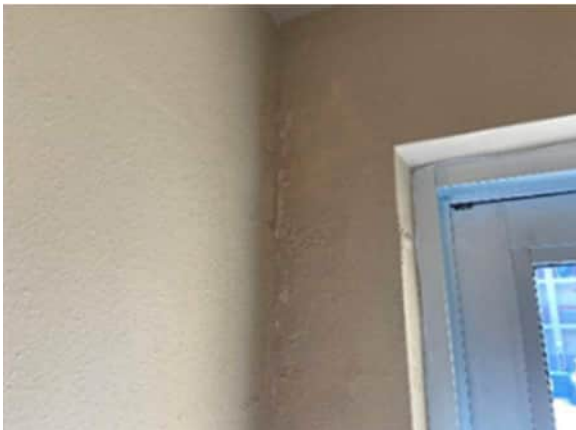
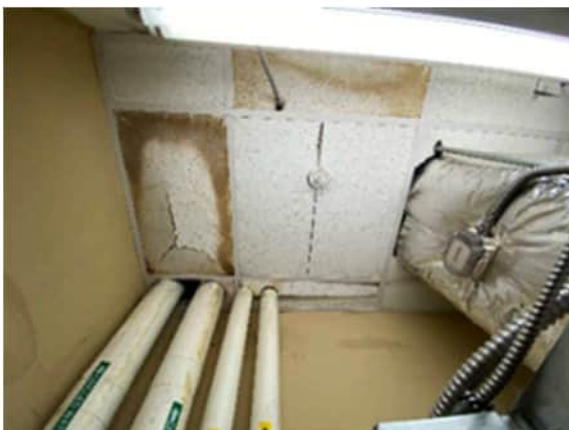
Common Areas:

- Moisture damaged building materials on perimeter wall near exit in 1st FL Common area
- Moisture damaged building materials on dropped ceiling of HVAC Closet in 1st FL Common area

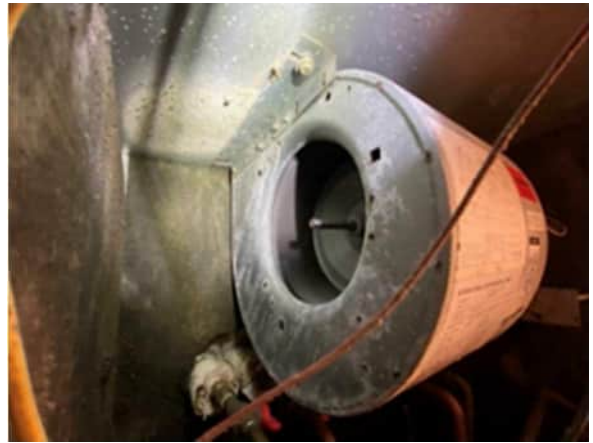
Occupied Units:

- No building materials were “wet” in units assessed
- Moderate dust load and Suspect Visible Mold on HVAC vents.

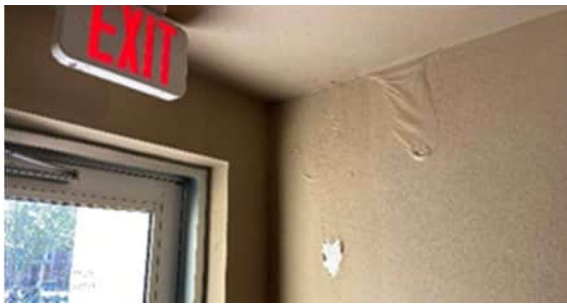
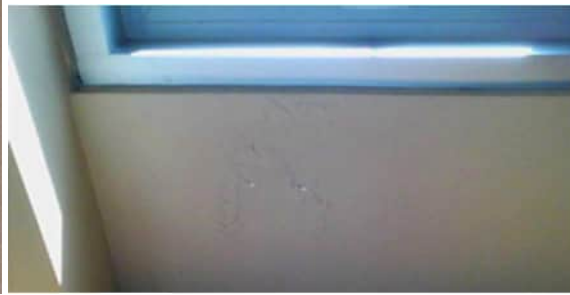
Common Areas:

- Moisture damaged building materials on perimeter wall near exit in 1st FL Common area
- Moisture damaged building materials on wall below east window on stair landing

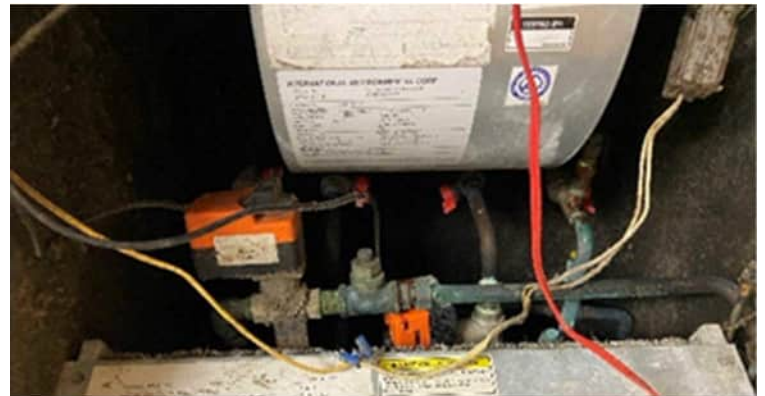
Occupied Units:

- Moderate dust load and Suspect Visible Mold on HVAC housing.
- No building materials were “wet” in units assessed

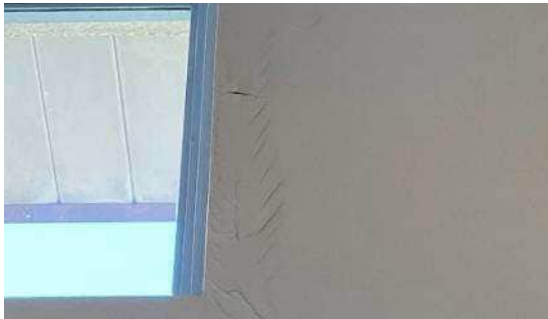
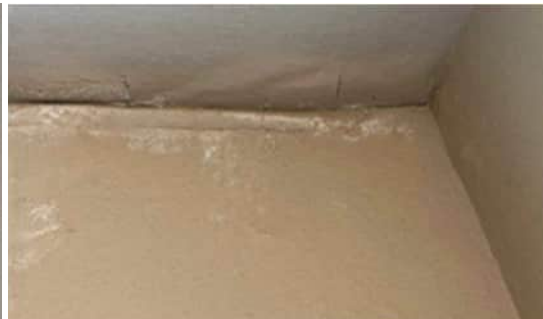
Common Areas:

- Moisture damaged building materials on perimeter wall near exit in 1st FL Common area
- Moisture damaged building materials on wall below window of north wall

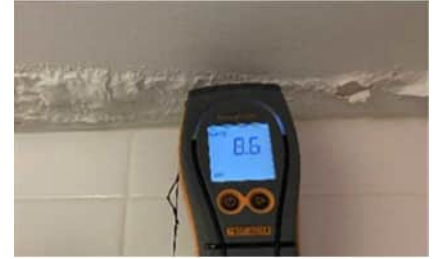
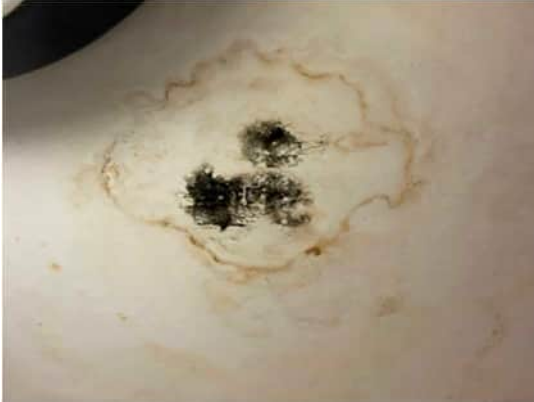
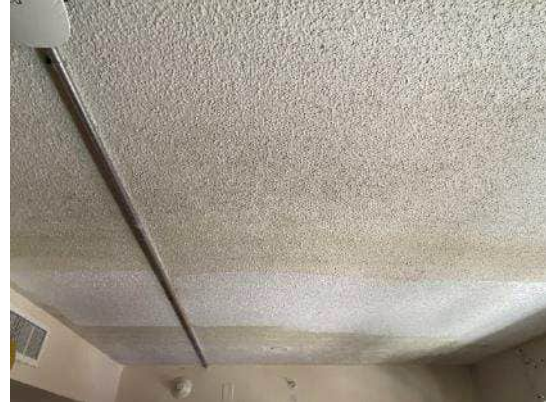
Building Goldstein

Goldstein – Minimal moisture damage observed in the occupied areas assessed. Water-stained ceilings in living areas adjacent to HVAC supply ducts could be contributed to sweating, duct seal failure or temperature differentials via introduced outside air. Visible mold on the ceiling of a unit restroom shower is likely to be a plumbing failure from the unit above.

- Moisture damaged ceiling and wall building materials
- Suspect Visible Mold on ceiling in restroom
- Moderate dust load and Suspect Visible Mold on HVAC vents.
- No building materials were “wet” in units assessed

- ❖ Remove water and/or mold damaged building materials within the restroom and in living areas.
 - Determine the source of the water/moisture and take appropriate corrective actions prior to the replacement of the building materials. Leaving water damaged building materials in place is not recommended due to the fact that mold, even though not visible, is present/dormant and will become active again quickly.

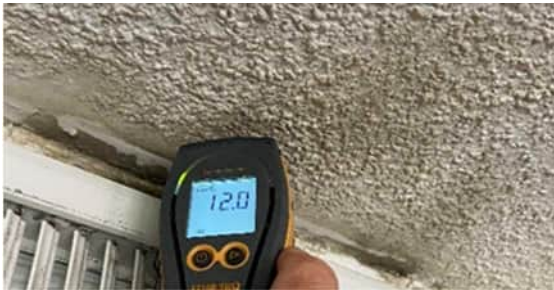
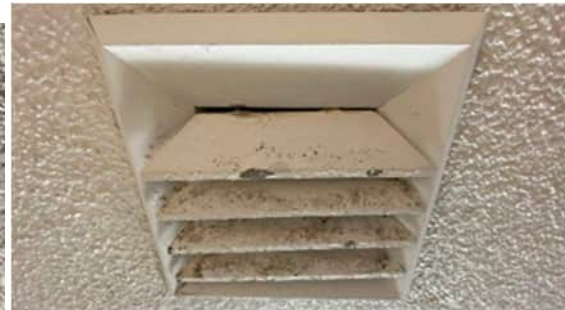
Building Dort

Dort – Minimal moisture damage observed in the occupied areas. The moisture staining on ceilings adjacent to HVAC supply duct vents could be contributed to sweating or seal failure or temperature differentials via introduced outside air.

- Moisture damaged ceiling and wall building materials
- Suspect Visible Mold on ceiling
- Moderate dust load and Suspect Visible Mold on HVAC vents.
- No building materials were “wet” in units assessed

- ❖ Dust and Suspect Visible Mold on supply diffusers can be addressed by housekeeping or maintenance by removing and brush cleaning with a soapy water. Use of rubber or foam seal between metal diffuser and ceiling or wall material will reduce the potential for moisture/water damage and SVM.
- ❖ Moisture damaged areas could be addressed by maintenance personnel and prevented through routine maintenance.
